Built between 1962 and 1983, the Urbino University Colleges ("Collegi Universitari di Urbino") are one of the most famous and significant works of Giancarlo De Carlo, Royal Gold Medalist for Architecture in 1993.

# The Getty Foundation “Keeping it modern” - Conserving Modern Heritage, Urbino’s University Colleges

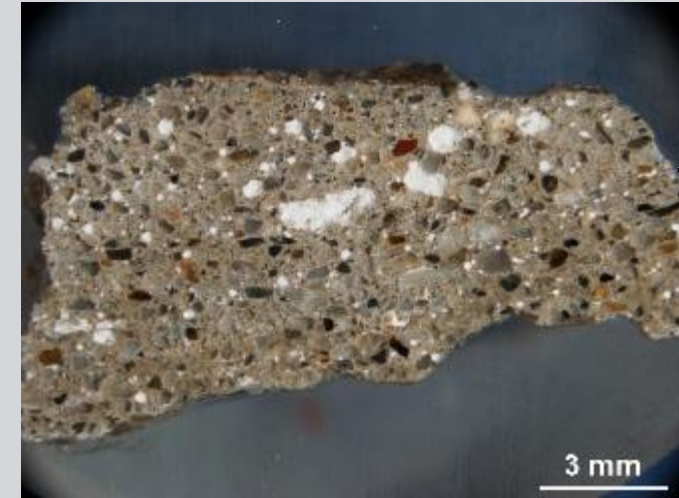
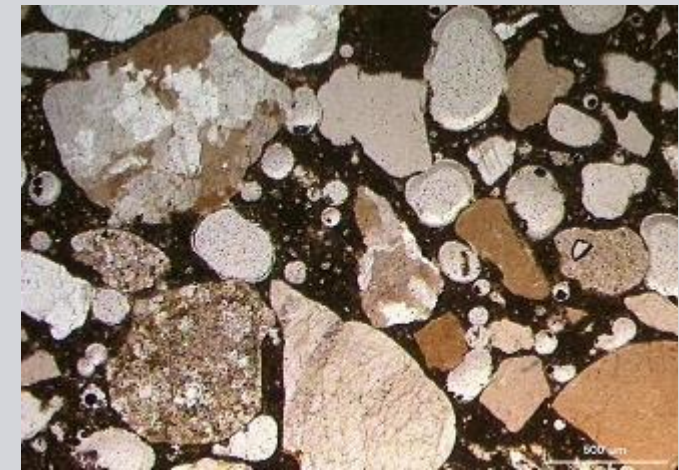
Observation of thin section with polarized light microscopy. Nicols //. Sample U10.

**Samples are coming from concrete structures, flooring composite materials, bedding mortars, joints, rendering materials with paint finishes.**

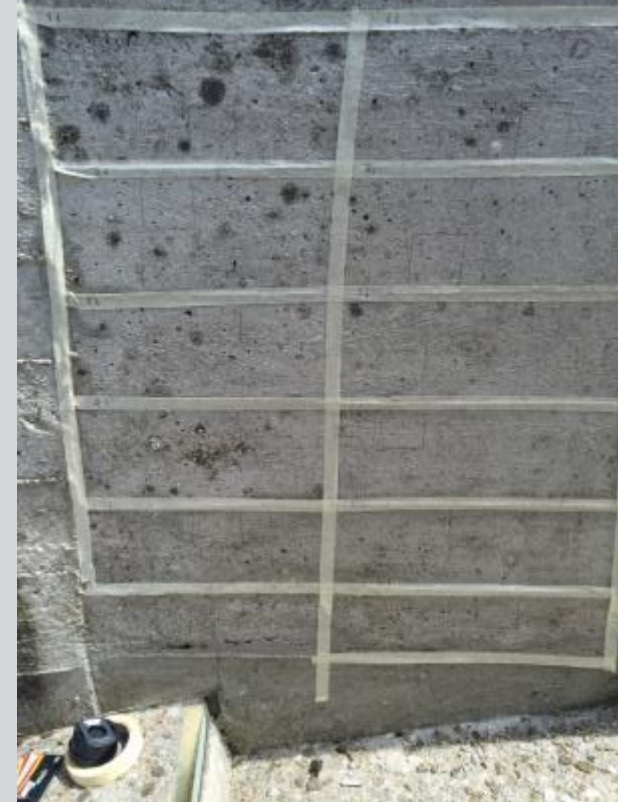
The second part of the study regards “**In field evaluation**” of conservation treatments and especially water repellents products. In this case a standard procedure can be adopted in order to get evidences of both effectiveness and possible harmfulness of the products. These latter have been chosen after a careful survey of what is available in the market. 13 different commercial products have been tested belonging to different chemical classes: silanes, siloxanes, fluorinated resins, acrylics. **The in situ evaluation have been carried out by means of reflectance colorimetry and water absorption by capillarity with the contact sponge method.** The evaluation of the product will be possible measuring the surface characteristics both before and after the application of the product. The same measure will be carried out as a final step of the project in order to understand the permanence of the water repellency after some month of ageing.

In the case of protective treatments 13 different commercial formulations have been tested. The products belongs to different chemical types: silanes, siloxanes, acrylics, fluorinated resins.

- Reflectance Colorimetry.
- Water absorption by capillarity with the contact sponge method

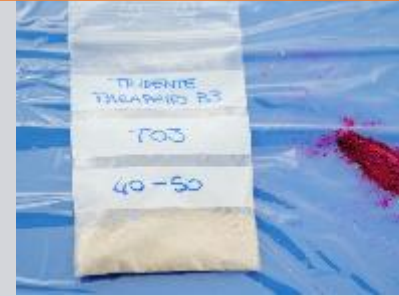
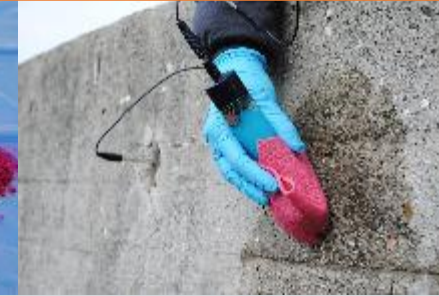
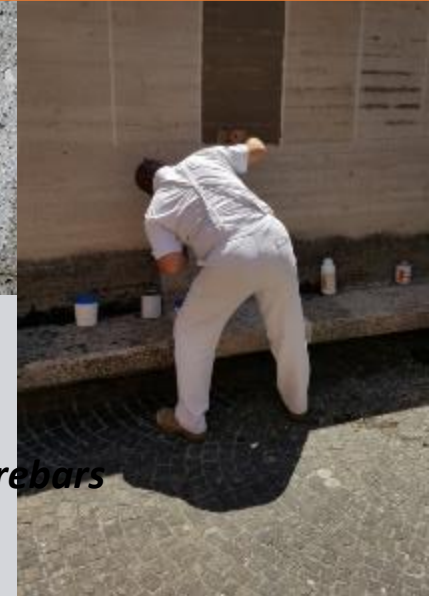
### IN FIELD EVALUATION

- Evidence of carbonate
- Tests to verify the potential for corrosion of rebars

Apply these techniques are not decisive (not solve the case Study of corrosion of reinforcement) there are cases where this material already decayed:

**How to run the patches?** In the 90 GDC realizes patches; He is still viable that solution? Is it possible to add thickness to perform greater protection of reinforcing rods?

**With which materials to make the integration?** Materials recovery (in the market): they have very different colors and textures from the concrete of the colleges; experimentation that we are running has the aim to understand how to reconcile the need to use a material commercially (coming over a requirement of the managers)

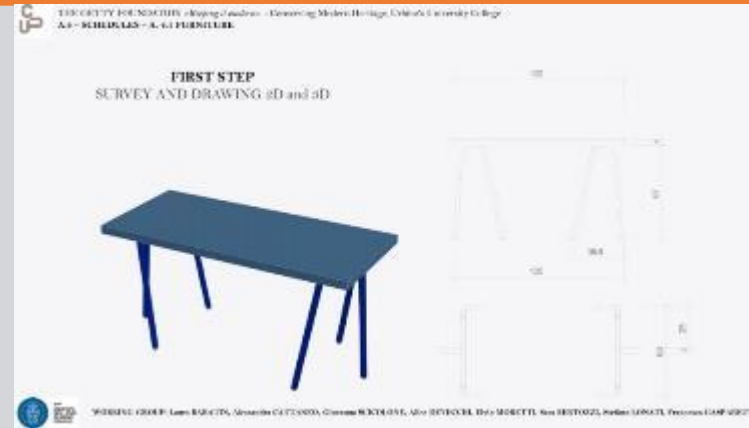
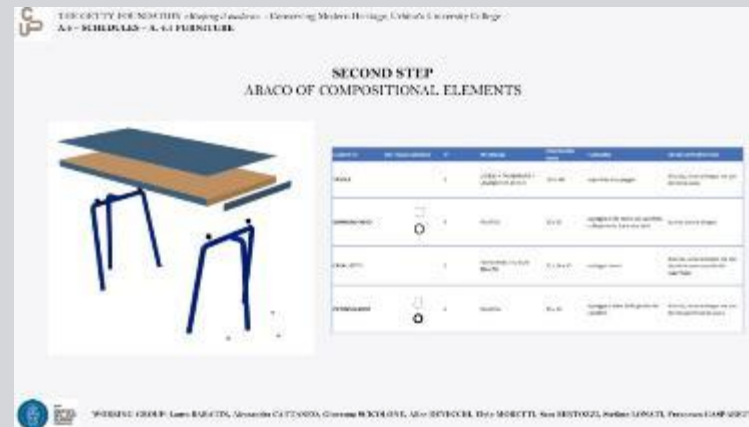
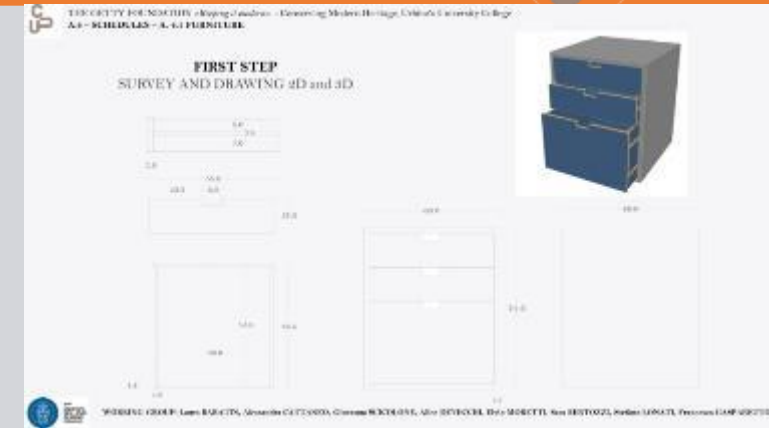
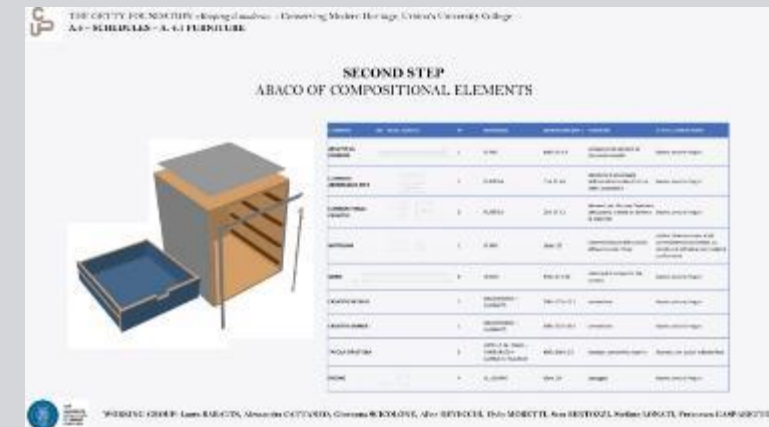
All information and actions are recorded in a database, and as a true "control" can be updated over time, to monitor the state of conservation of the property and program interventions.

On the right you see a "view" of the program, which allows managers to order the doors and windows on the basis of conservation status, then immediately identifying the most urgent cases that need work

Below you see the state of conservation and analysis of the degradation of daily use objects:

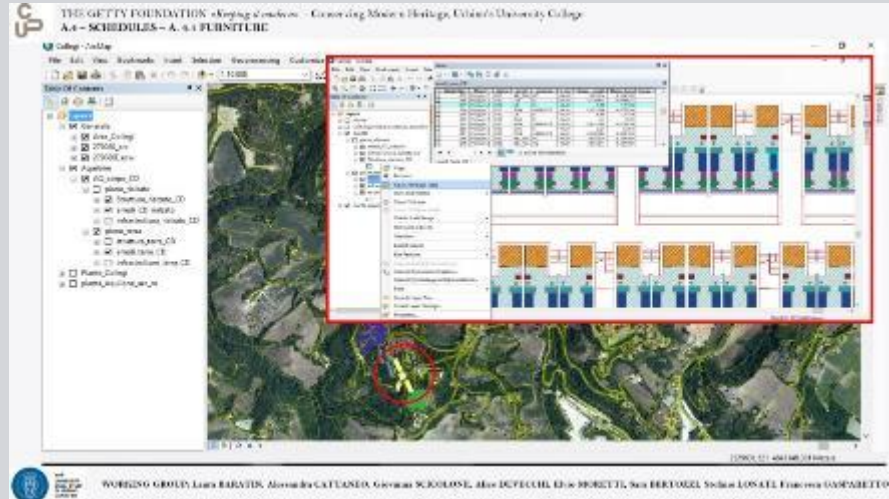
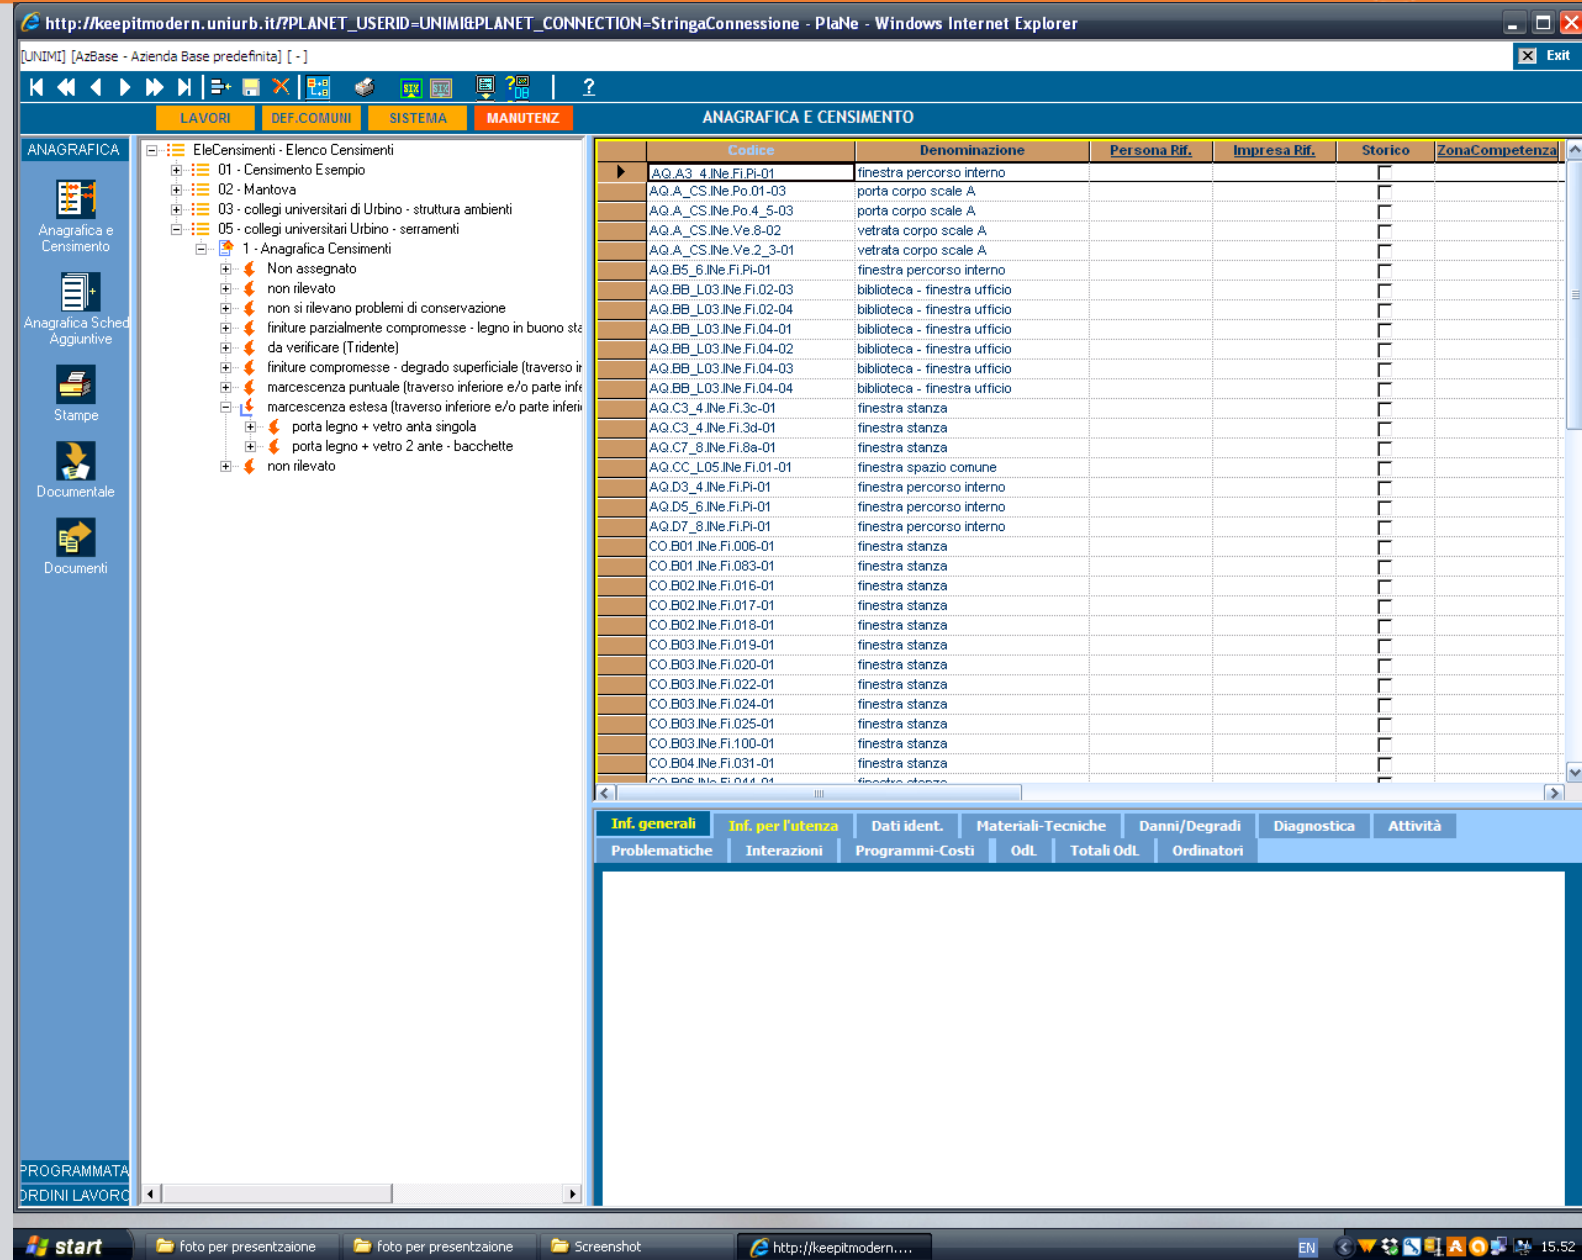
GIS for georeferential objects within the Complex and **Condition Report** on the State of Conservation and intervention of each objects
